TOWN OF AURORA
ADDITIONAL ITEMS
FOR HERITAGE ADVISORY
COMMITTEE MEETING

- **Delegation (b) Lora Cai, Owner of 15342 Yonge Street** pg. 1
Re: Item 2 – Report No. HAC15-010 – Demolition Application for a Structure on a Designated Heritage Property, Demolition of an Accessory Barn, 15342 Yonge Street, NE-HCD-HPA-15-04

RE: Additional Information to Heritage Advisory Committee Report No. HAC15-007 -
32 Wellington Street East, Final Disposition of the "David W. Doan House"
Designated under Part IV of the *Ontario Heritage Act*

Re: Peer Review of Structural Engineering Report
32 Wellington St. East, Aurora, Ontario

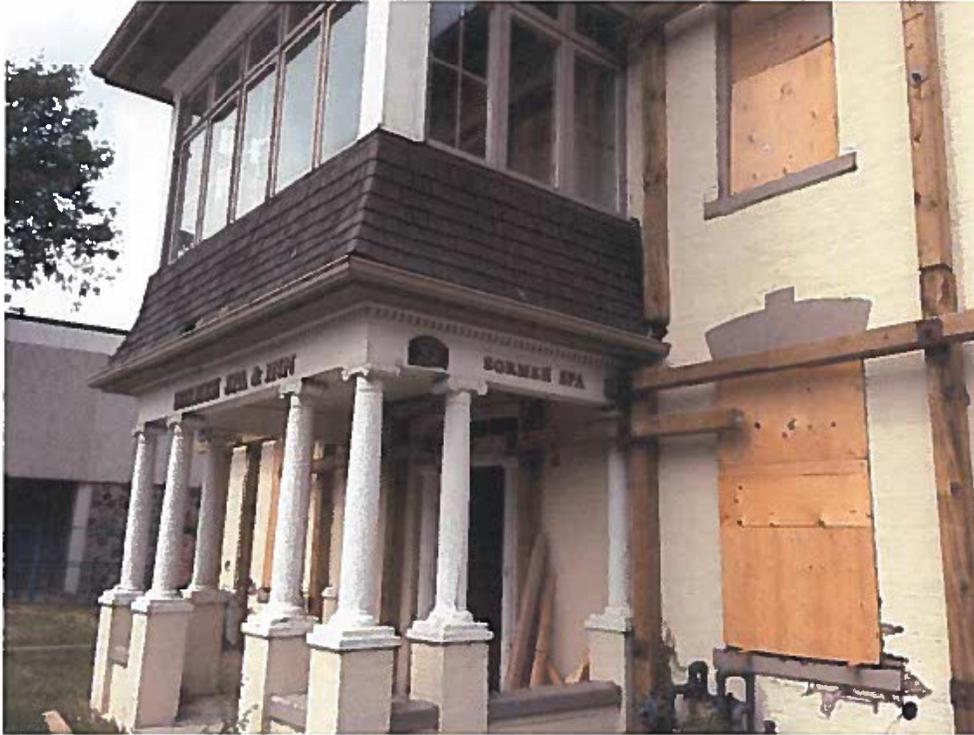
Picture #1 – 32 Wellington Street East (South Elevation)

Above grade face bricks on south elevation are generally in fair condition with signs of mortar deterioration in a few localized areas generally caused by water infiltration. There are no visible cracks and any signs of differential settlement on south wall.

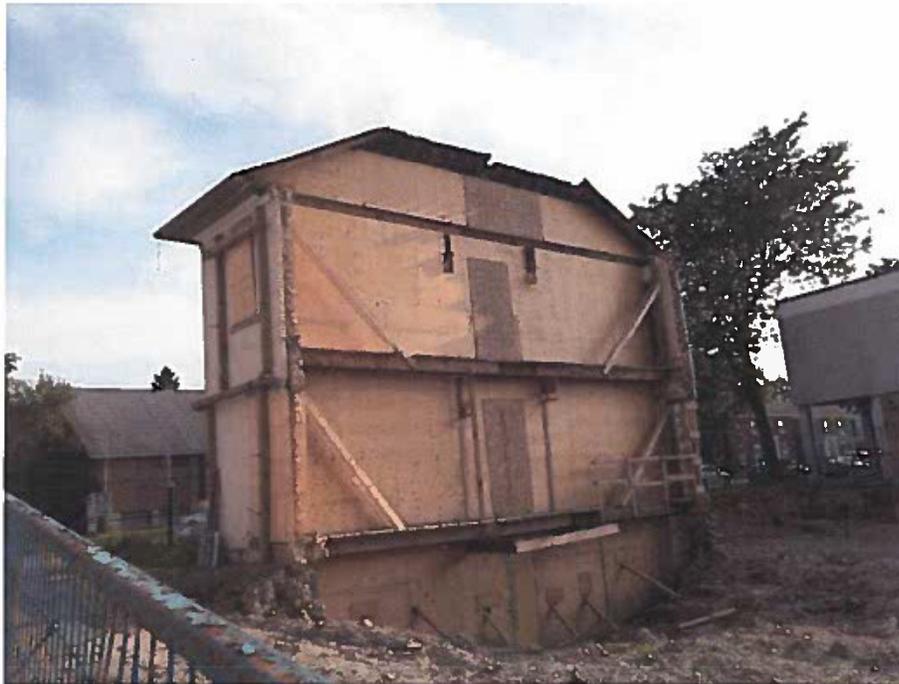
Picture #2 – 32 Wellington Street East (North Elevation)

The building structure remaining in place is a combination of brick masonry load bearing walls and wood framing. Exterior east and west walls consist of 4" brick veneer, 2" air space and 8" thick double brick back up. It is to be noted that this differs from the existing exterior wall shown on the structural drawings which has been assumed to be (9" thick brick masonry wall. South (front) wall is assumed to be of same construction. North wall has been demolished and has been reconstructed as a 2x6@16" o/c temporary stud wall supported on a temporary 20"x20" dead man footing and two permanent 6'-6"x6'-6"x18" deep pad footings as part of the shoring drawings issued for demolition permit (Picture #2).

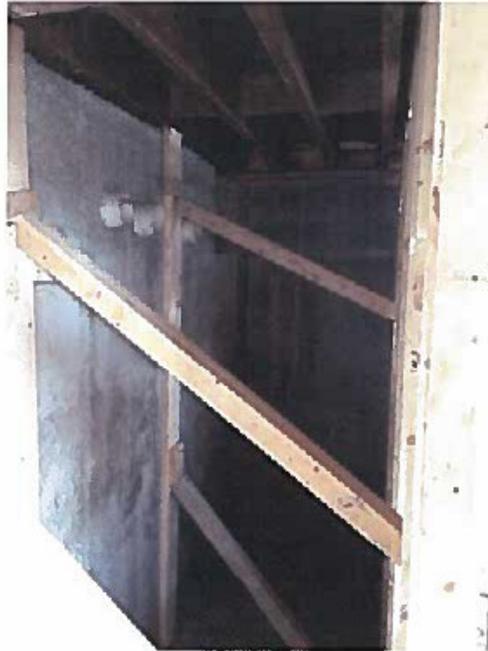
Picture #3 – Foundation wall at basement level

Existing rubble stone masonry walls in the basement walls were not visible. New cast in place concrete walls have been constructed against the inside face of the rubble masonry wall. Underpinning of walls has also been completed and appears to be in general accordance with underpinning permit drawings. Weeping tile system and damp-proofing of foundation walls will have to be incorporated to the existing structure to prevent water penetration into the basement.

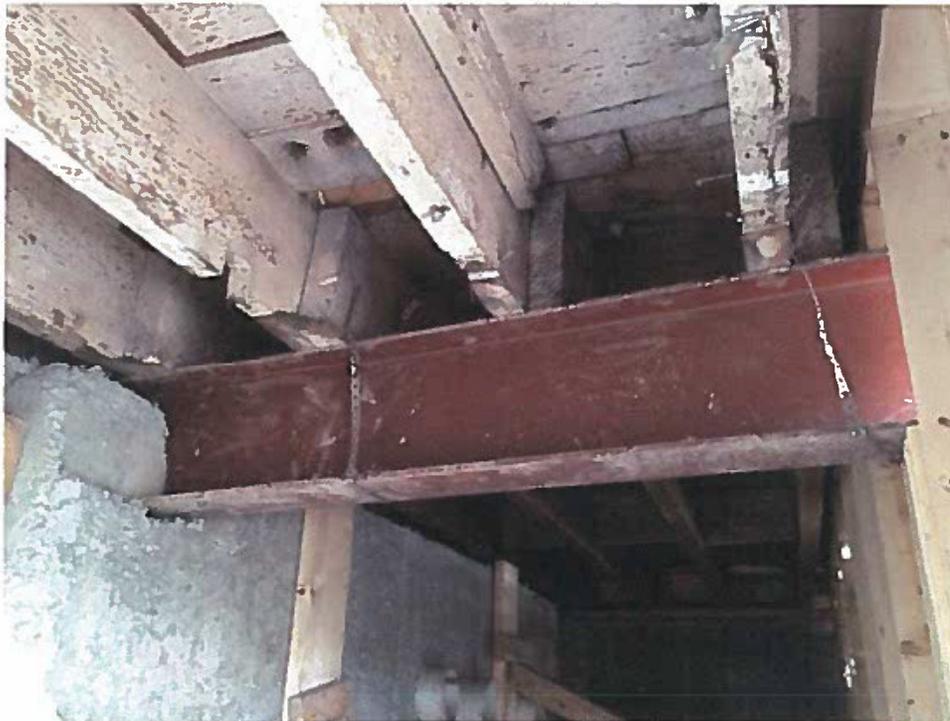
Picture #4 – Steel beam supporting ground floor framing

Shoring of the basement foundation walls has been completed with some variations from the issued for demolition permit drawings. 2-4x4 wood posts at approximately 4'-0" o/c have been used in lieu of the steel telescopic jacks for the north wall (Picture #3). Two walls on east and west side do not have any shoring. Two steel beams have been installed picking up the existing ground floor joists at two support lines along gridlines 4a and 6. The steel beams are supported on the new foundation wall on the south side and on steel shoring posts on the north side (Picture #4).

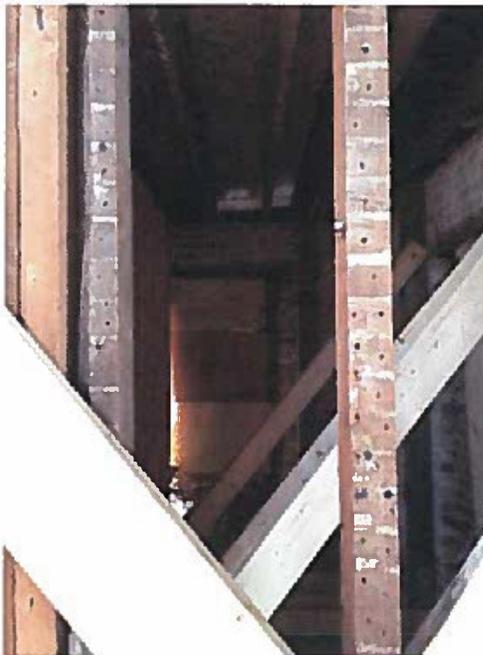
Picture #6 – Shoring at second floor

Access to most of the interior area of the building structure is blocked from the diagonal braces installed as part of the shoring work. Interior of east and west walls could not be reviewed closely from inside (Picture #6). The inner load bearing brick wythes were visible at north end where demolition on south side has been carried out. Exterior above grade inner load bearing brick veneer walls observed at these two areas of the building are in generally poor condition with signs of mortar deterioration and crumbling of the bricks (Picture #7). Efflorescence was also noted on the bricks at a few areas inside the building (Picture #8) which is an indication of moisture penetration.

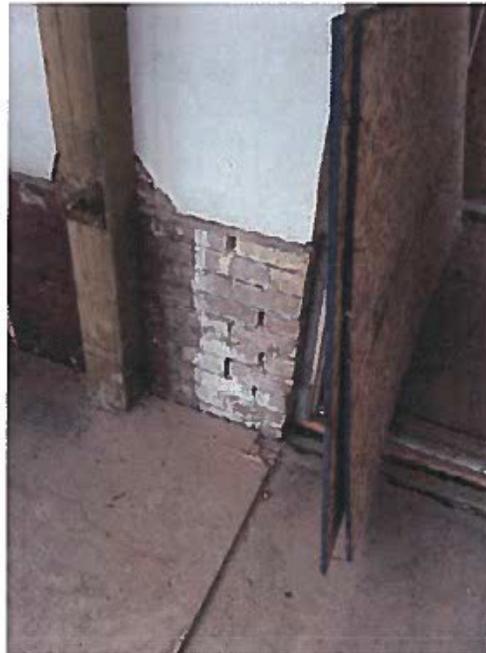
Picture #8 – Efflorescence at second floor wall

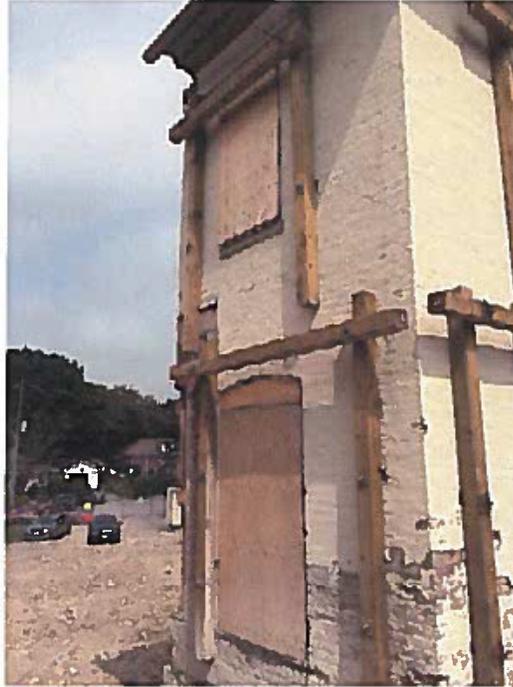
Above grade face bricks on east and west elevations appear to be in generally fair condition with a few cracks in localized areas below and above window openings. Some of the cracks appear to be new and very likely were caused during and/or after demolition. Removal of existing masonry walls north of window openings may have resulted in some movement as effectiveness of arch lintel over the window opening is diminished. (Picture #9, 10).

Picture #9 – Outer façade damage at west elevation

In our opinion, with existing bracing in place procedure outlined above to save face brick is not a feasible option. We concur with Soscia Professional Engineers Ltd. recommendation that entire wall shall be removed and re-constructed to match existing architecture. In our opinion, it will be prudent to remove entire existing structure and re-construct with proper damp-proofing and insulation in accordance with OBC requirements.

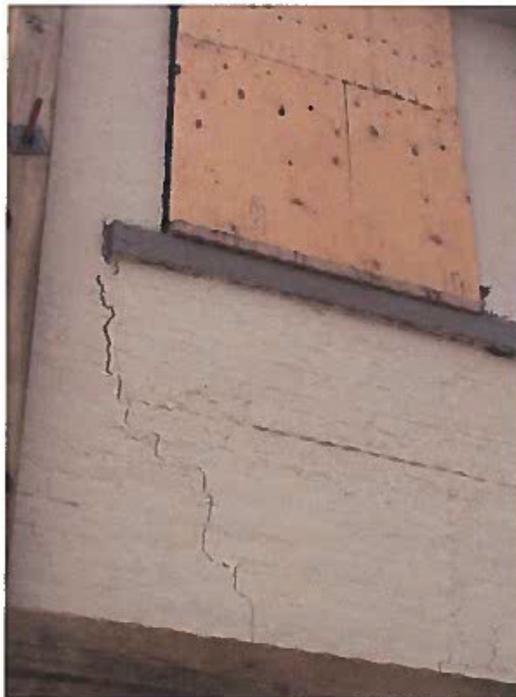
Picture #10 – Outer façade damage at east elevation

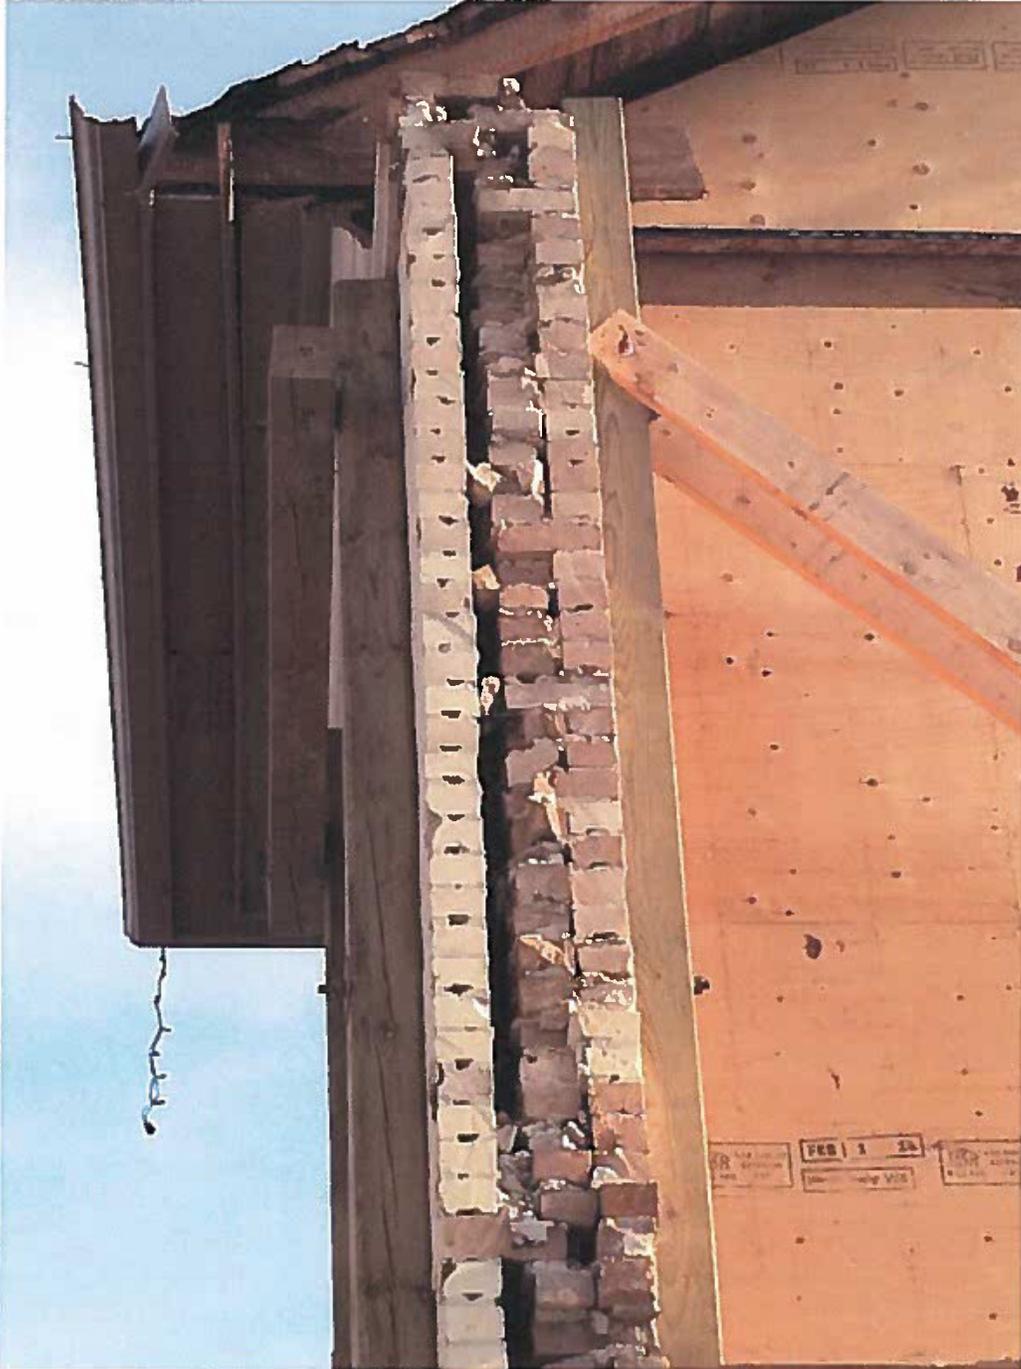
Metal ties between 4" face brick and 8" backup brick wall could be observed only at two locations where 2" cavity between inner and outer brick was visible (Picture #11). At both locations, brick do not meet the minimum tie spacing required as per Table 9.20.9.5 of the Ontario Building Code 2012. Two brick wythes of load bearing back wall appears to be tied together with tie bricks at about 2 to 3 feet c/c vertically (Picture #12). Horizontal spacing of brick ties could not be determined.

Face brick is generally in fair conditions except for some cracks in localized areas around existing window openings and section of east wall being out of plumb. Spalling of the brick is present at isolated locations in the wall. Face brick is not adequately tied to back up load bearing bricks. Metal ties to load bearing back up bricks do not meet the minimum tie spacing required as per Table 9.20.9.5 of the Ontario Building Code 2012.

Picture #11 – Brick ties at east wall

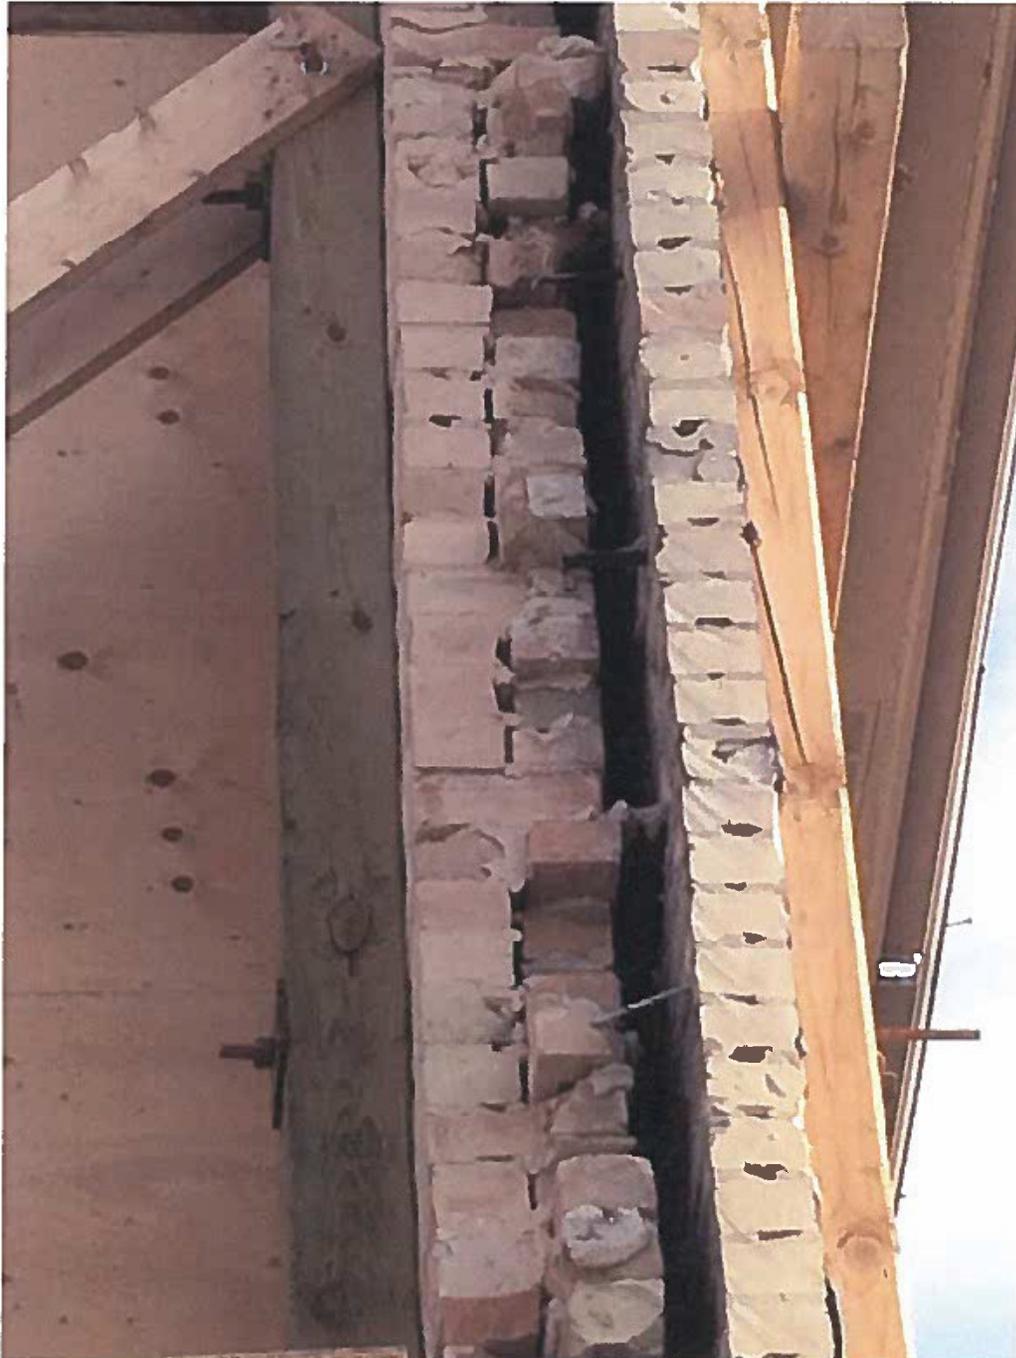
Picture #12 – Brick ties at west wall

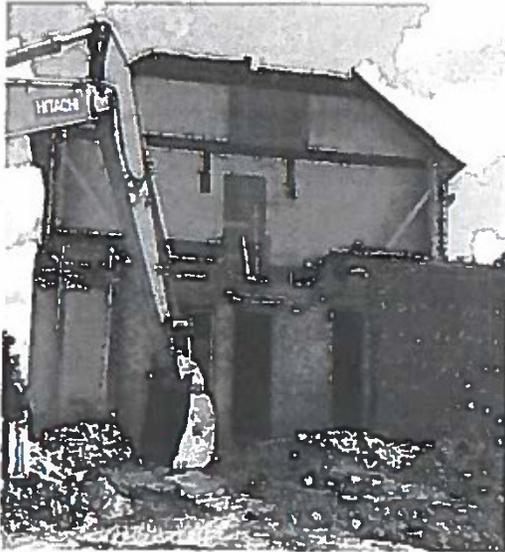
DEMOLIITON IN PROGRESS AT 32 WELLINGTON STREET EAST. DEVELOPER HAS ADEQUATELY UNDERPINNED AND SHORED AS PER THE PERMIT REQUIREMENTS.

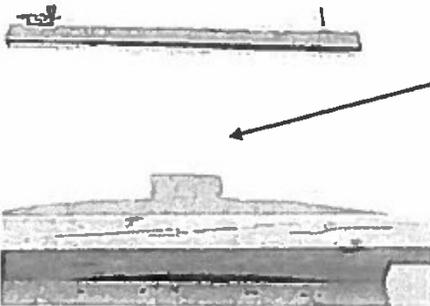
New cracks have appeared in the exterior façade. May have resulted from inadequate ties of a result of the demolition procedures.
