TOWN OF AURORA
ADDITIONAL ITEMS
FOR HERITAGE ADVISORY
COMMITTEE MEETING

- **Delegation (b) Lora Cai, Owner of 15342 Yonge Street** pg. 1
Re: Item 2 – Report No. HAC15-010 – Demolition Application for a Structure on a Designated Heritage Property, Demolition of an Accessory Barn, 15342 Yonge Street, NE-HCD-HPA-15-04

RE: Additional Information to Heritage Advisory Committee Report No. HAC15-007 -
32 Wellington Street East, Final Disposition of the "David W. Doan House"
Designated under Part IV of the *Ontario Heritage Act*

Re: Peer Review of Structural Engineering Report
32 Wellington St. East, Aurora, Ontario

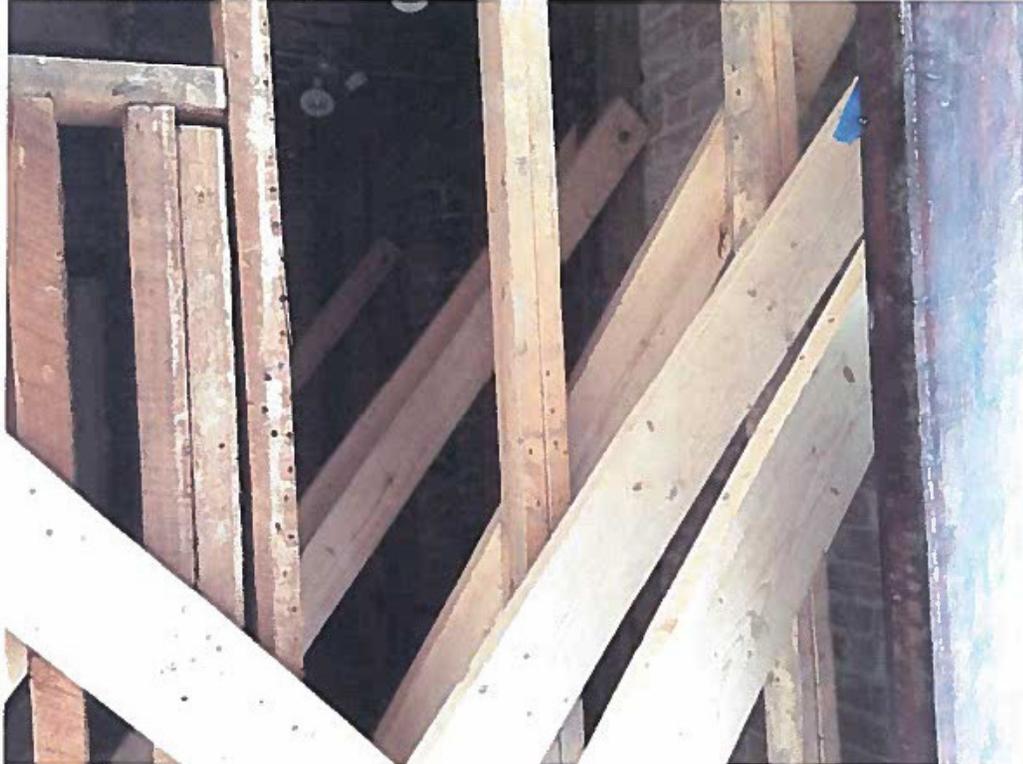
Typical ground and second floor construction consists of 2"x10" @16" c/c joists spanning in east-west direction and are supported on exterior walls and two beams running north-south on gridlines 4b and 6. Diagonal braces at ground and second floor have been installed as per demolition drawings (Picture #5).

Picture #5 – Shoring at ground floor

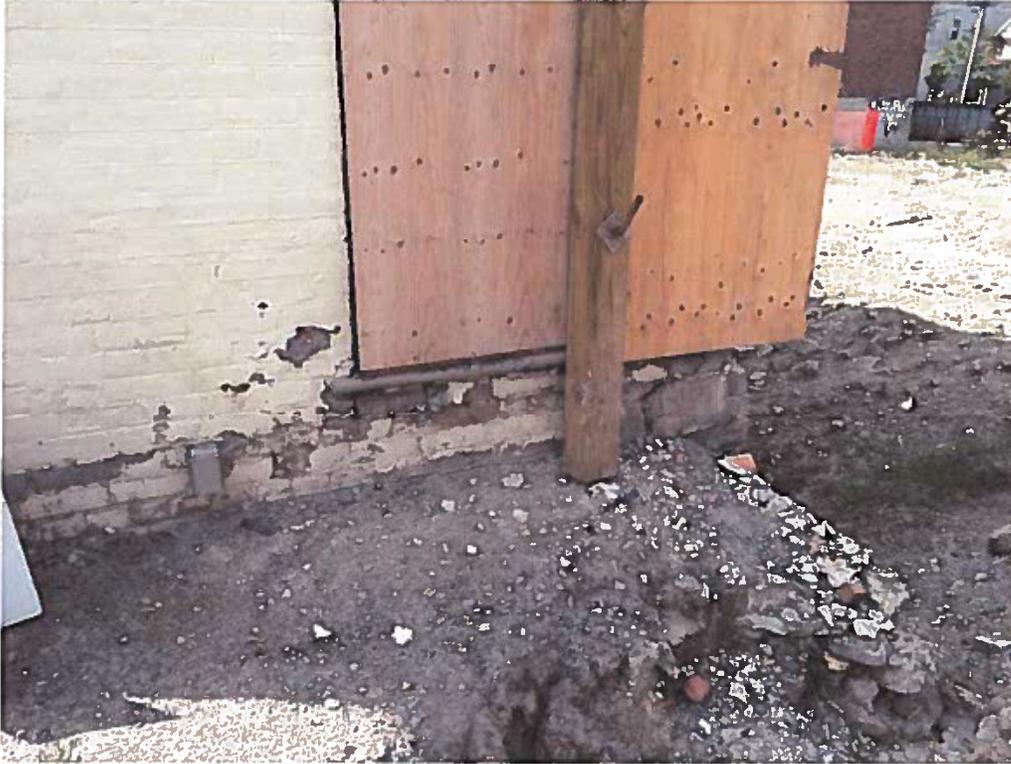
Picture #7 – Exterior wall at north-east corner
